CONTINUING ELIGIBILITY INSPECTION (CEI) REPORT
FOR FLOOD CONTROL PROJECT
Honolulu Engineer District
CEPOH-EC-T

1. Project Name: Wailoa FCP
2. Date of Inspection: November 18, 2003

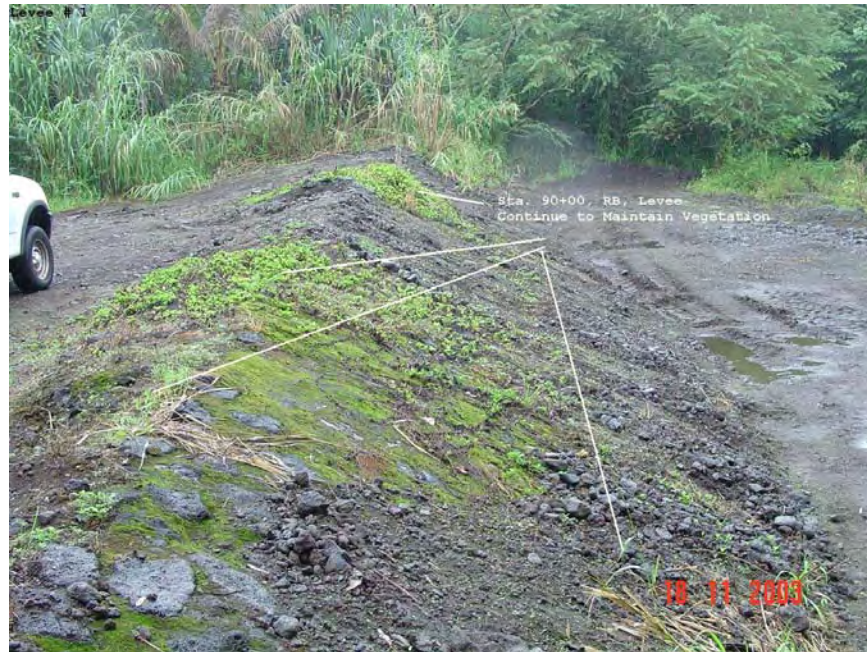
a. Sta. 90+00, Right Bank (RB) Looking Upstream at Levee #1, continue to remove vegetation.

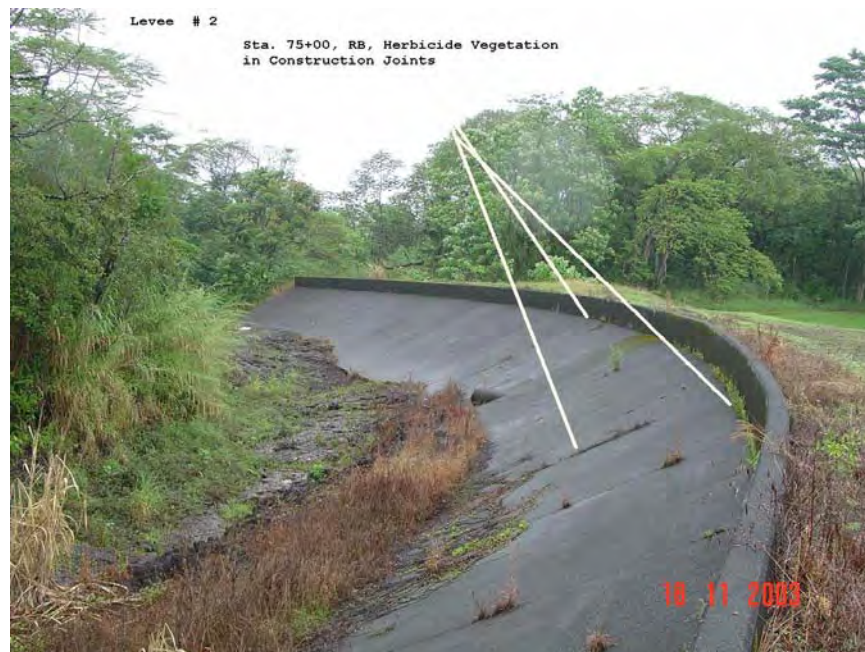
b. Sta. 75+00, Right Bank (RB) Looking Downstream at Levee #2, herbicide vegetation growing in weep holes and construction joints.

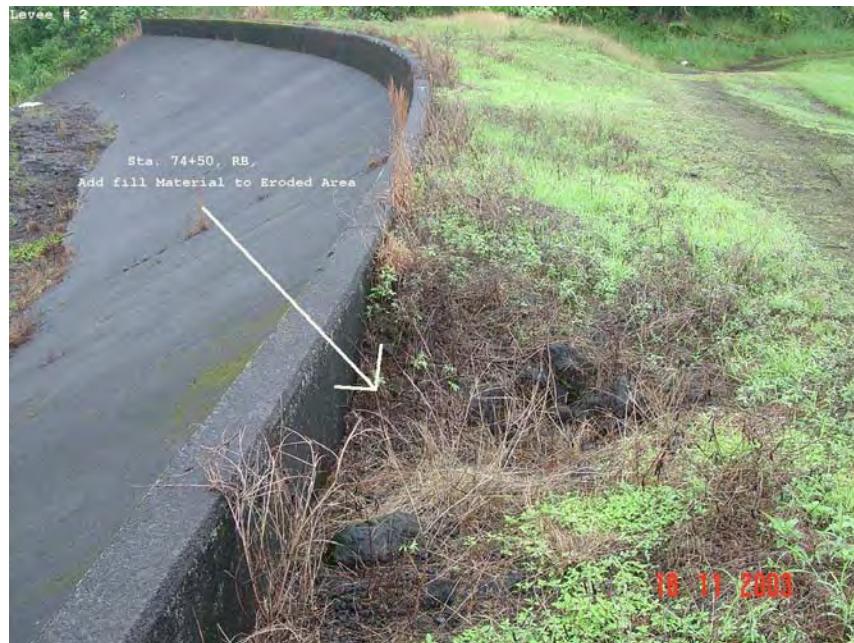
c. Sta. 75+50, RB, add fill material to eroded area.

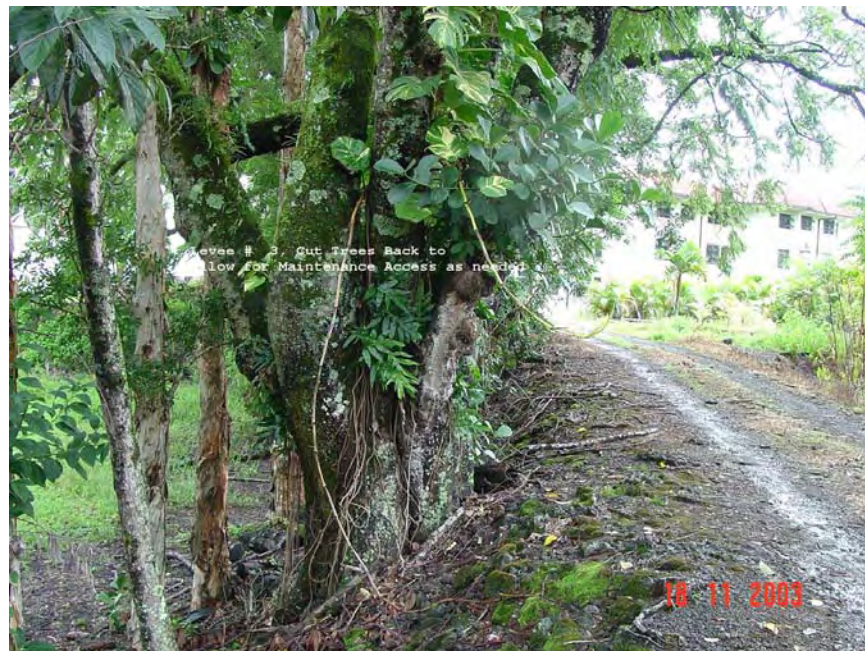
d. Sta. 59+00, Right Bank (RB) Looking Downstream at Levee #3, cut back trees as needed.

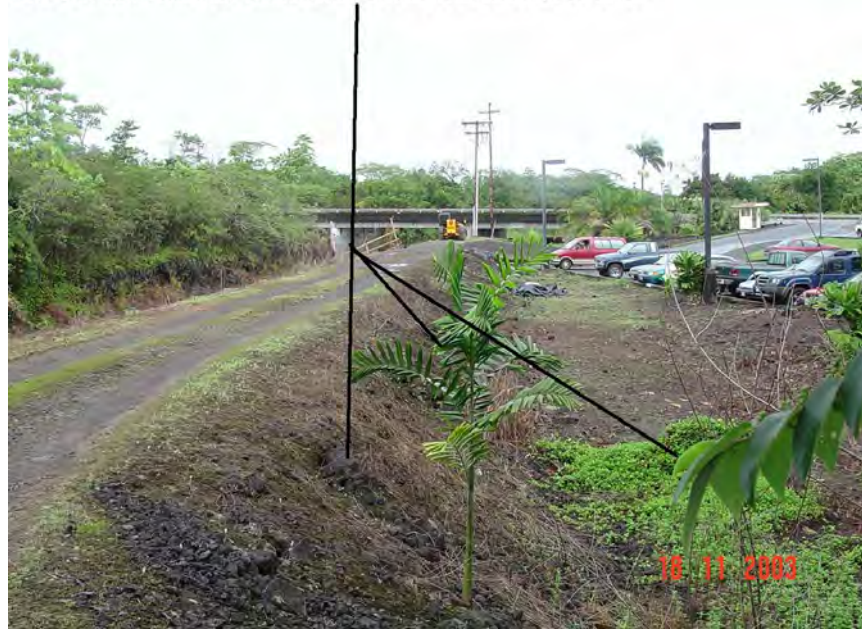
Levee # 3, Sta. 59+50, RB, Remove Juvenile Trees from Sideslope of Levee

e. Sta. 59+50, Right Bank (RB), Looking Downstream at Levee #3, remove juvenile trees from sideslope.

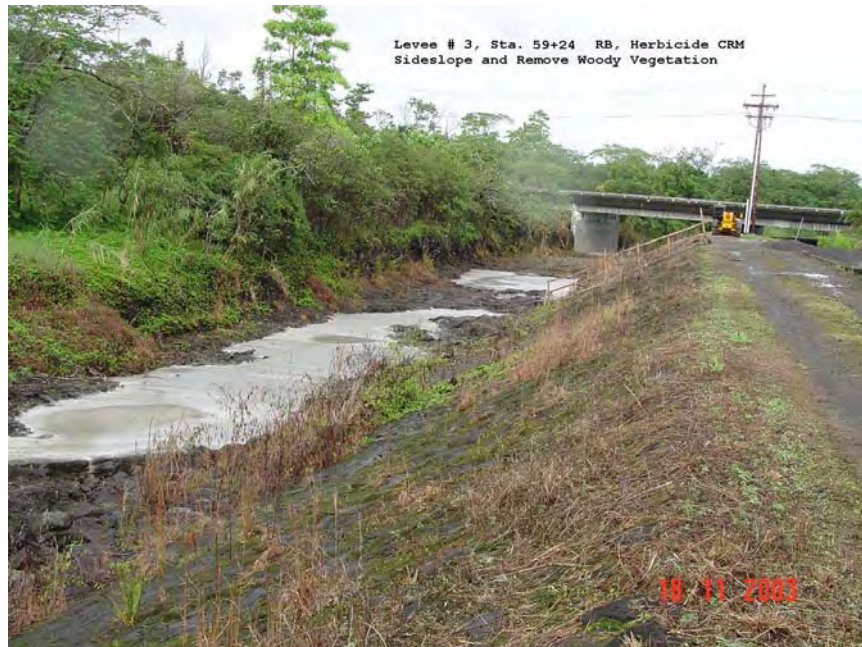
f. Sta. 59+24, RB, Looking Downstream, Levee #3, remove vegetation.

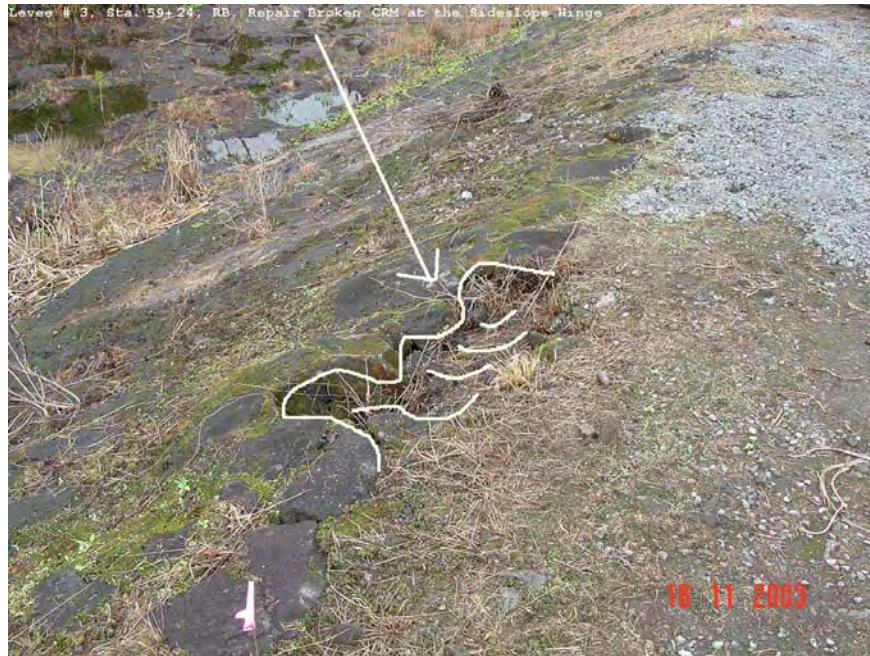
g. Sta. 59+24, RB, Looking Downstream, Levee #3, patch CRM.

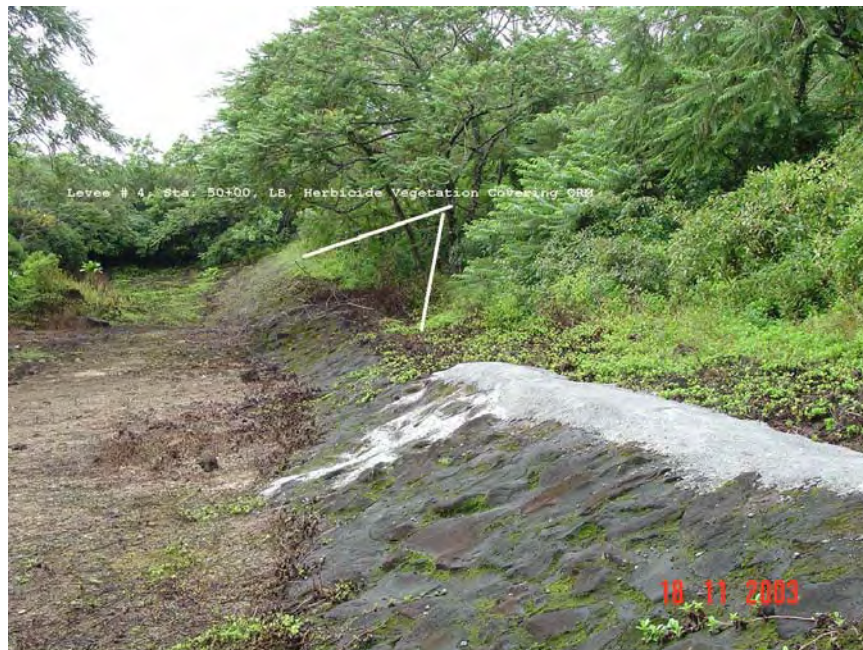
h. Sta. 50+00, Looking Downstream at Levee #4, herbicide and remove vegetation.

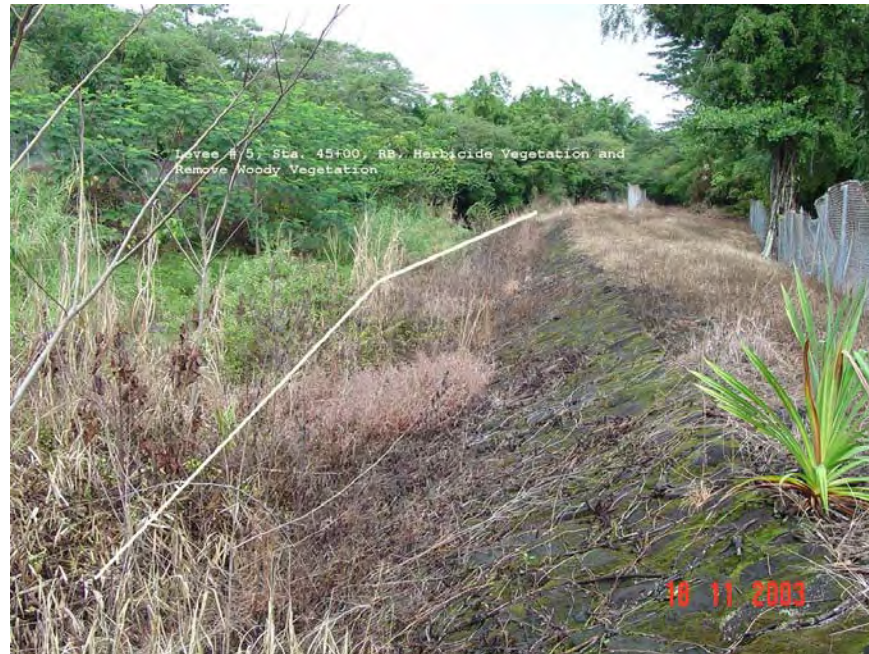
i. Sta. 45+00, Right Bank (RB) Looking Downstream on Levee #5, herbicide and remove vegetation.

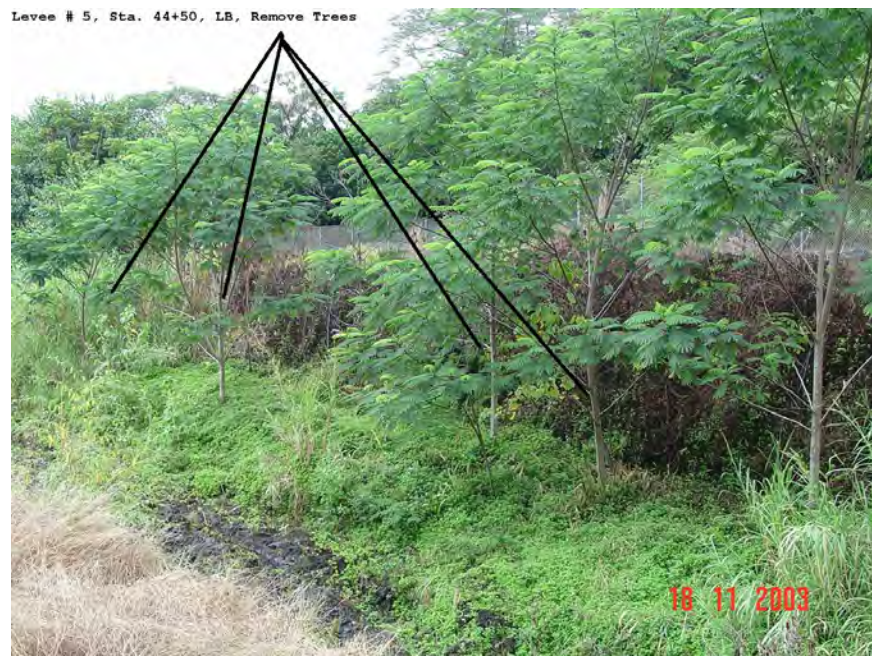
j. Sta. 45+00, Left Bank (LB), remove trees and herbicide vegetation.

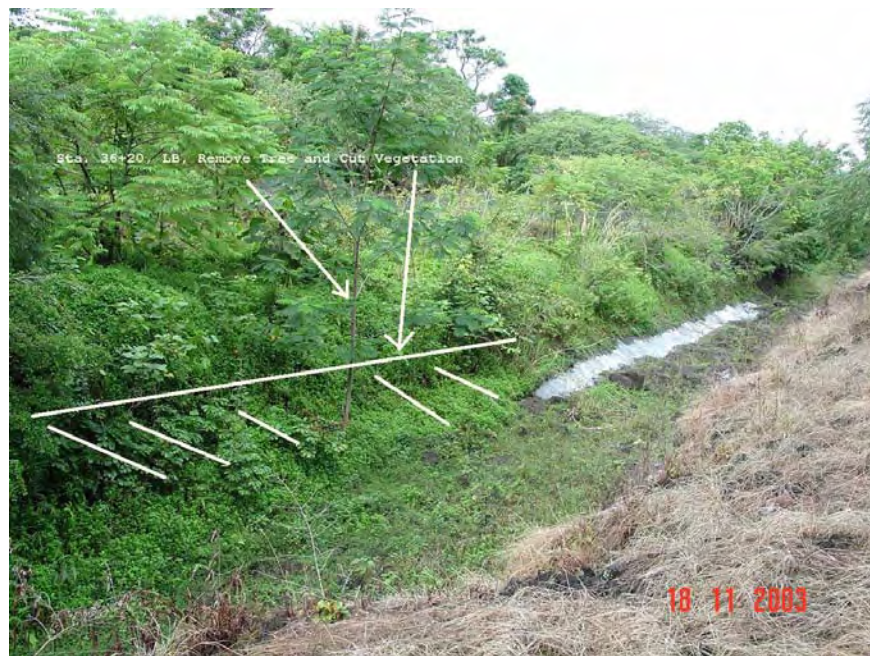
l. Sta. 36+20 LB, Looking Downstream, remove tree and vegetation unable to inspect sideslope.

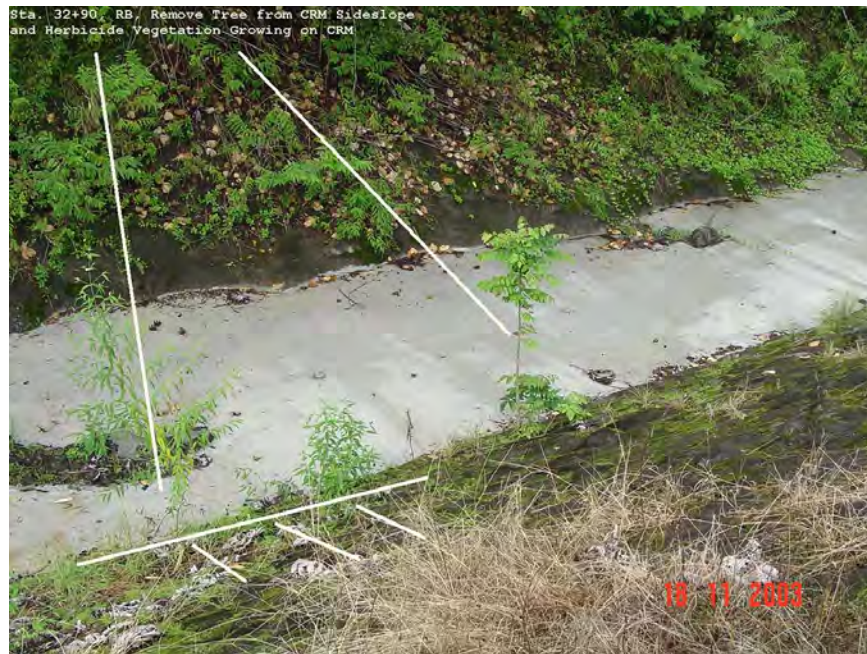
m. Sta. 32+90, Right Bank (RB), remove woody vegetation from CRM sideslope.

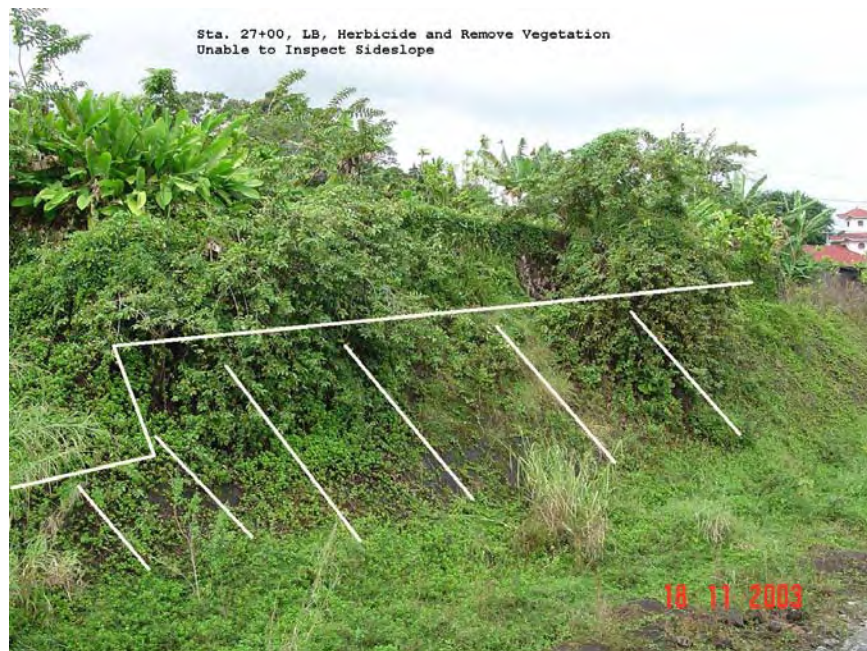
n. Sta. 27+00, LB, herbicide and remove vegetation, unable to inspect sideslope.

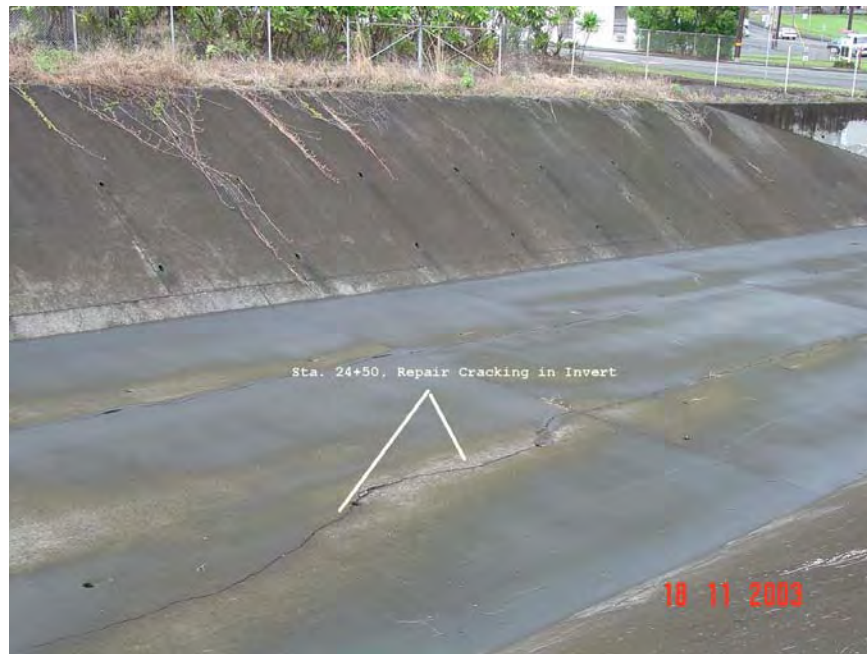
- o. Sta. 24+50, Above Kinoole Street Bridge repair / caulk cracking invert.

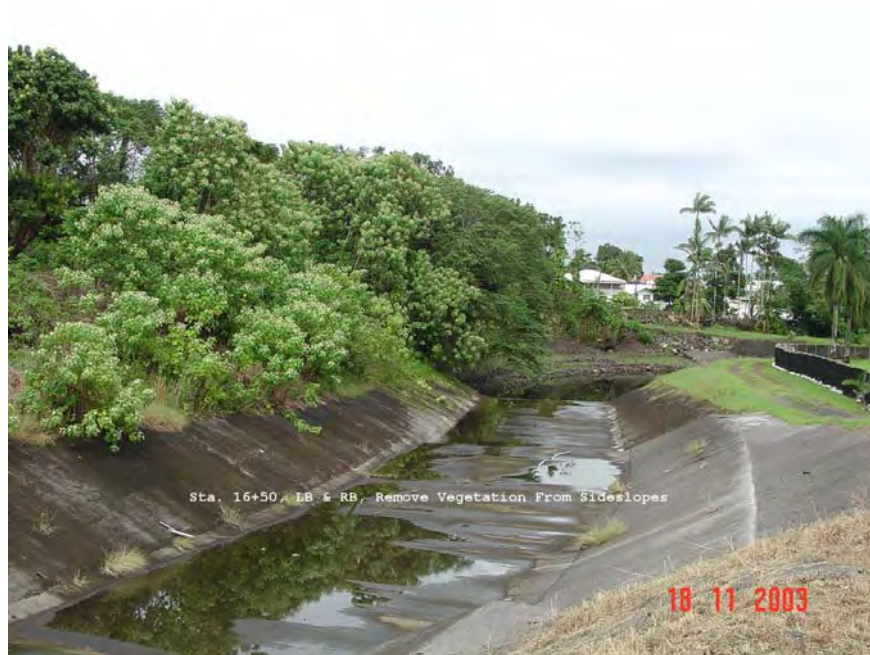
- p. Sta. 16+50, RB, Looking Downstream of Kinoole Street Bridge, herbicide and remove vegetation from sideslope.

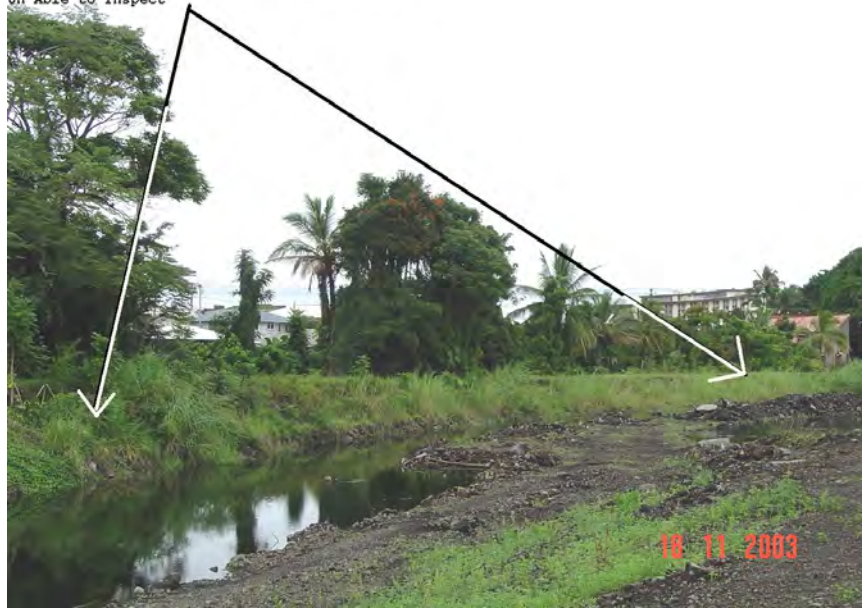
Sta. 12+00 to Sta. 6+00, LB & RB, Herbicide and
Remove Vegetation from CRM Sideslope
Un Able to Inspect

q. Sta. 12+00 to Sta. 6+00, LB & RB, herbicide and remove vegetation, unable to inspect sideslope.

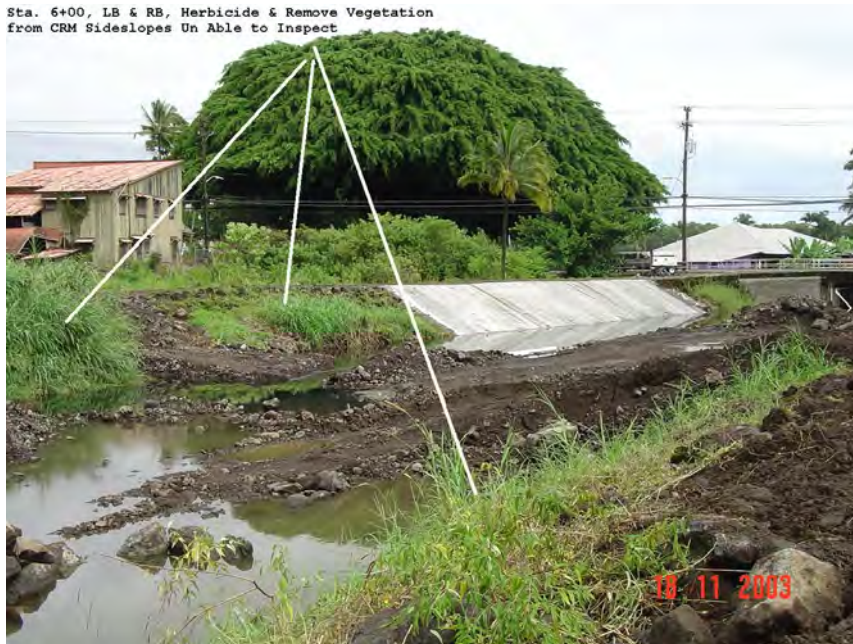
Sta. 6+00, LB & RB, Herbicide & Remove Vegetation
from CRM Sideslopes Un Able to Inspect

r. Sta. 6+00, RB & LB, herbicide and remove vegetation, unable to inspect sideslope.

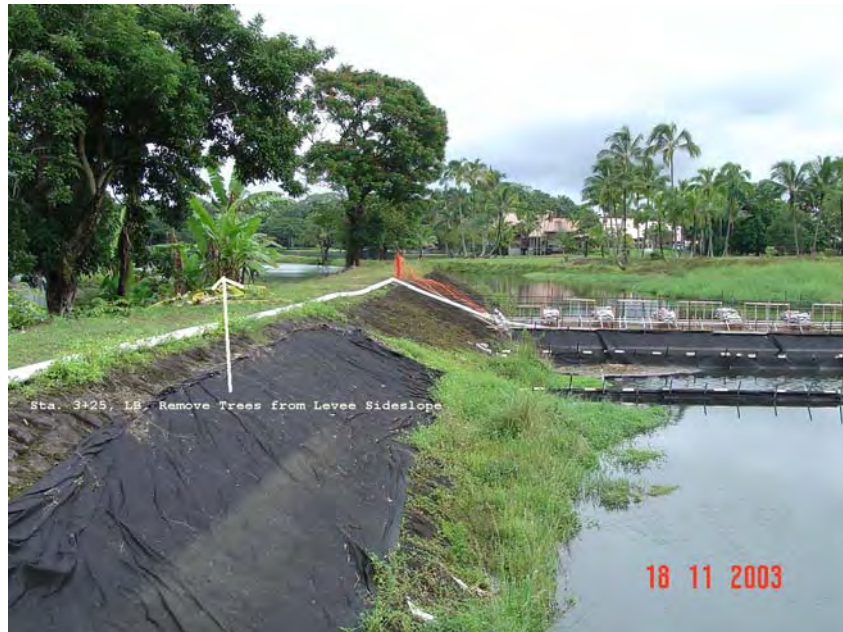
s. Sta. 3+25, LB, remove banana tree.
